Safety Inspection Report

Annual Inspection

Stoughton PC - Gaulby Lane Play Area

20 August 2024

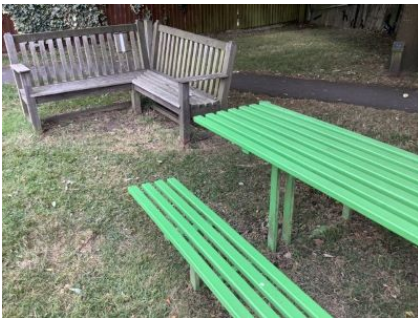
The equipment is dirty or algae covered.

Clean off.

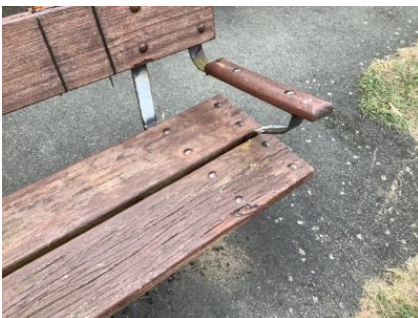
Timber is splintered.

Repair.

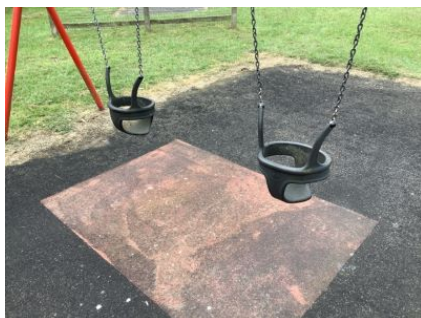
There is wear to the surfacing due to foot drag.

Although the seats are set at an acceptable height it is recommended that these are raised by 100 mm to help prevent wear.

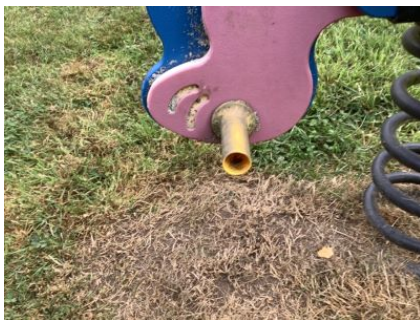
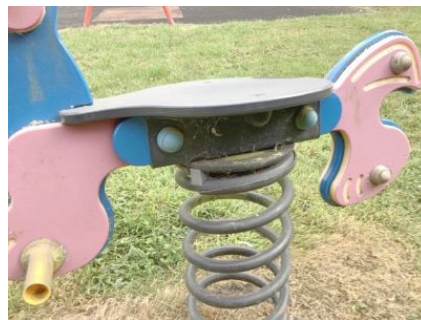
Fixtures loose or missing.

Rocker body bolts to connectors.
Cap/s are missing allowing water ingress into the frame and fixtures. Replace.

Tighten/replace.

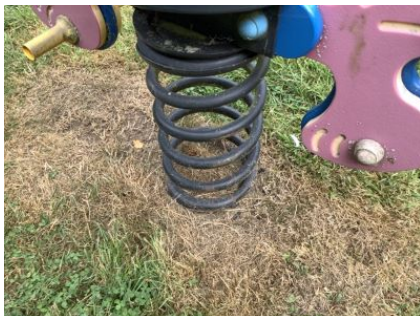
The spring is rusty. These have been known to fail without warning, leading to a collapse of the unit.

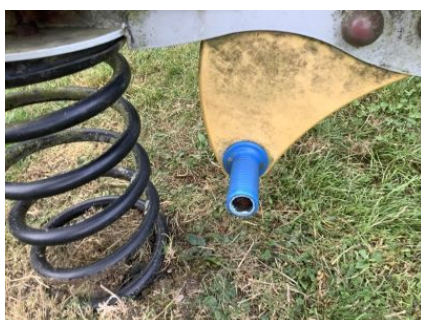
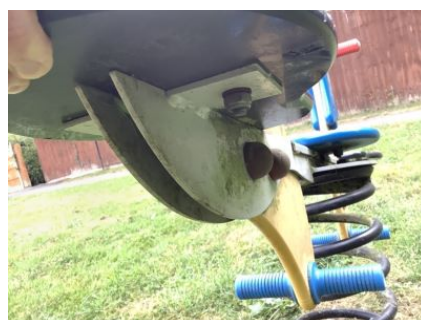
Cap missing.

Replace.

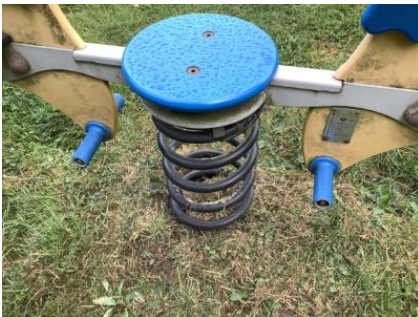
Fixtures loose or missing.

Foundation plate is very loose. Secure.

Tighten/replace.

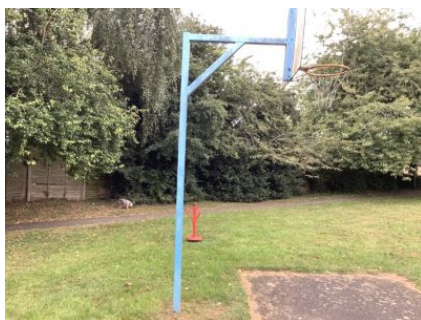
Loose in ground.

Slightly loose in the ground socket and leaning forwards.

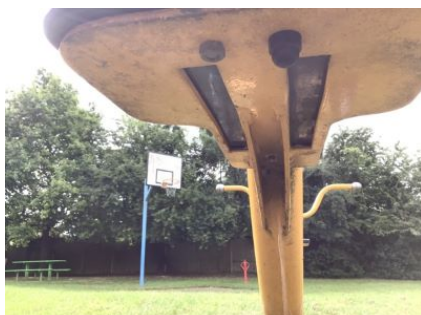
Fixtures loose or missing.

One seat bolt fixtures. Replace.
Hand hold bolts. Tighten.

Tighten/replace.

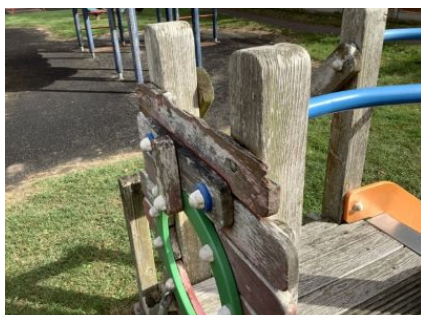
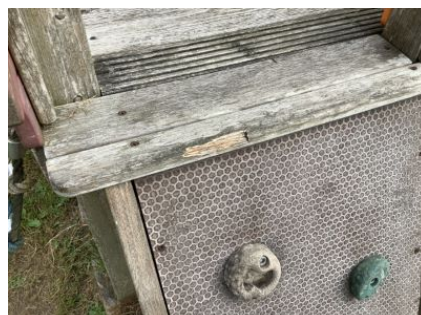
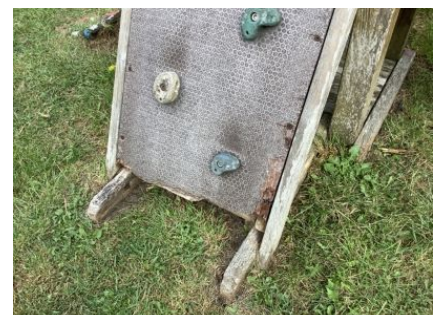
Timber is not in good condition.

Several timbers throughout unit. Replace.

Replace.

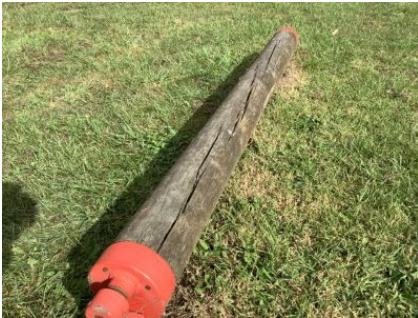
Monitor shakes for decay.
Monitor all natural timber shakes. Shakes are creating slight splintering. Smooth off if necessary.

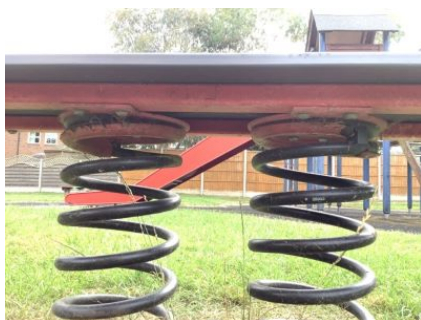
Item is rusting in places.

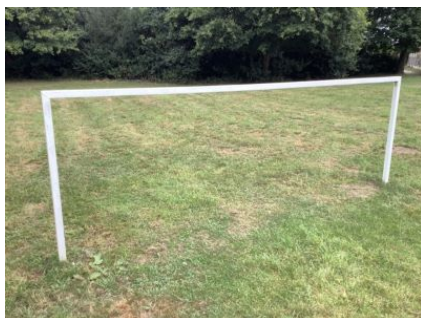
Loose in ground.

Repair.

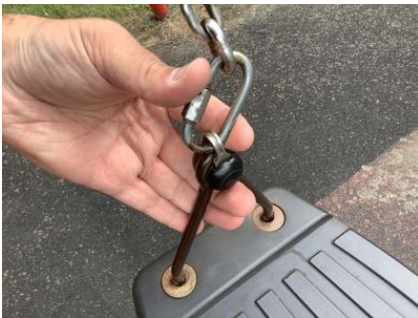
Some chain wear.

Monitor for further deterioration and replace before 40% wear.

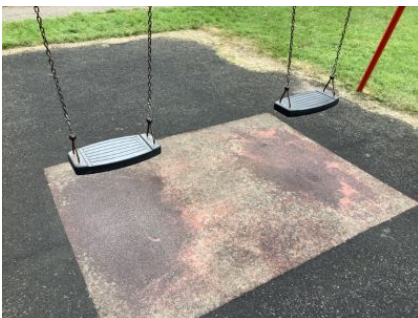
There is wear to the surfacing due to foot drag.

Although the seats are set at an acceptable height it is recommended that these are raised by 100 mm to help prevent wear.

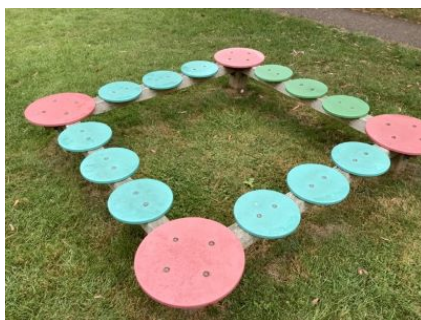
Bolt(s) loose.

Multiple loose panels.

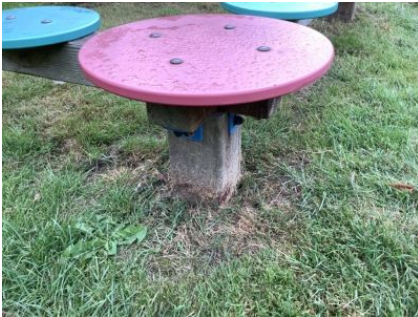
Strimmer damage is present on posts, allowing water to enter and timbers to soften. It can also remove the protective envelope around the timber. Prevent further damage and check timbers for decay throughout the year.

Strimmer damage is present on posts, allowing water to enter and timbers to soften. Prevent further damage and check timbers for decay throughout the year.

Prevent further damage.

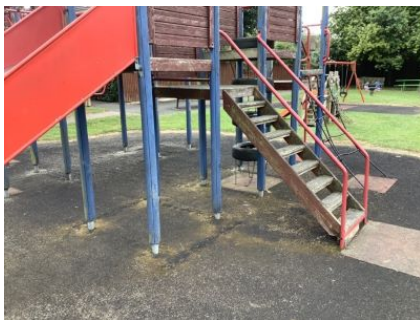
Algae growth giving slippery conditions.

Powerwashing is recommended. Care should be taken to ensure that the material can sustain high pressure washing.

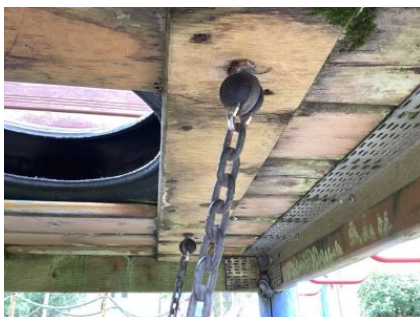
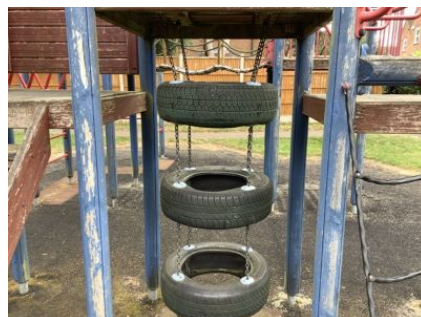
Some chain wear.

Monitor for further deterioration and replace before 40% wear.

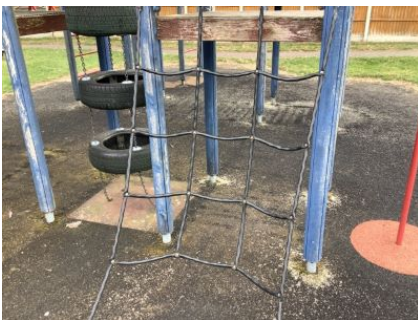
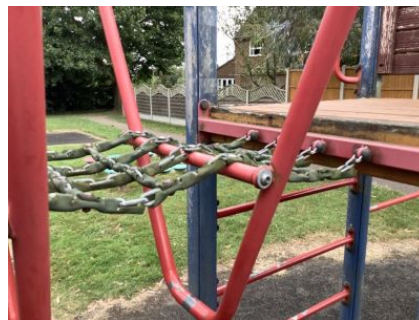
All chain covers are damaged leaving sharp edges. Replace.

Remove chain covers to inspect according to manufacturer's instructions, and replace the covers when done.

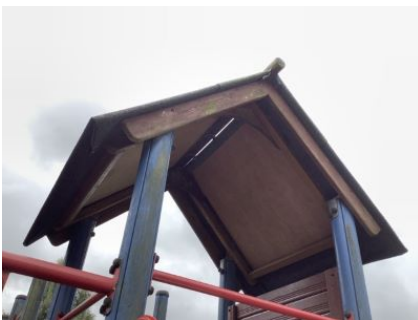
Fixtures loose or missing.

Slide tower roof is loose due to missing fixings.

Tighten/replace.

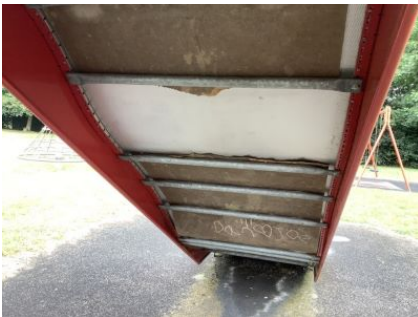
Item is damaged.

Replace and repair damaged sections.

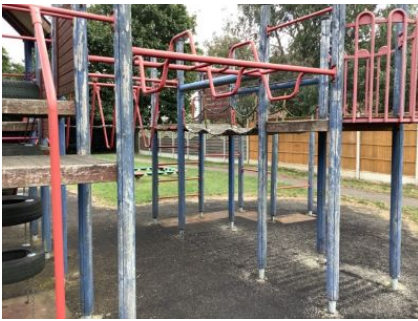
Item edges are worn.

Tyres are worn exposing metal frames. Replace.

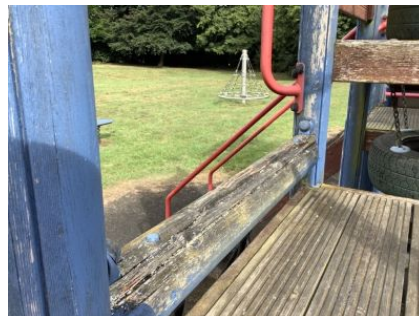
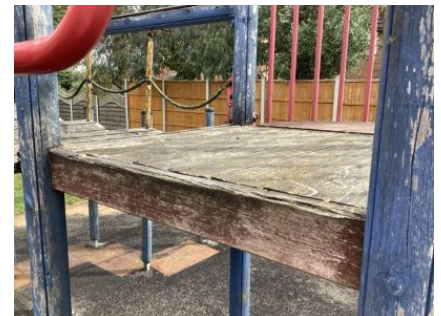
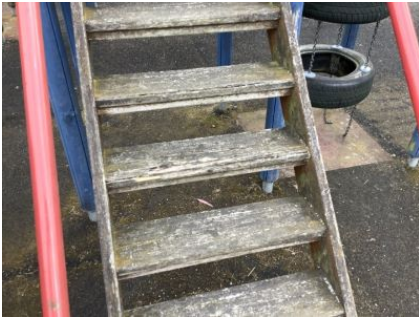
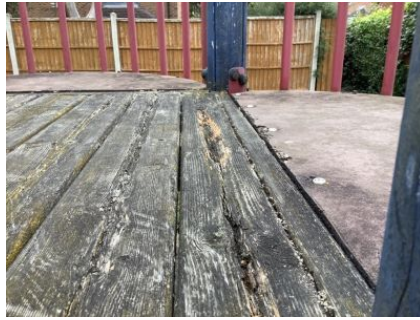
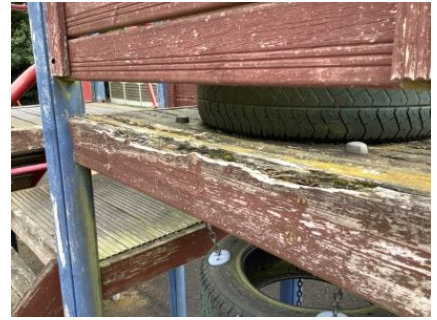
Timber is not in good condition.

Several timbers throughout unit. Replace affected parts.
Replace access steps and platform timbers.

Replace., Repair.
