Safety Inspection Report

Annual Inspection

Stoughton PC - Gaulby Lane Play Area

07 August 2023

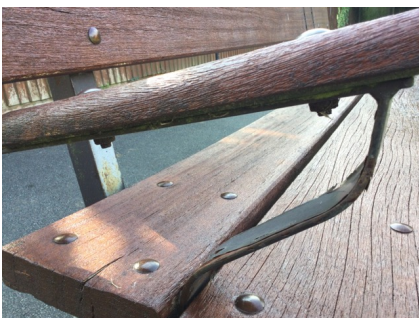
Projecting bolt thread.

Cut off and file down to remove sharp edges or use the correct length of bolt.

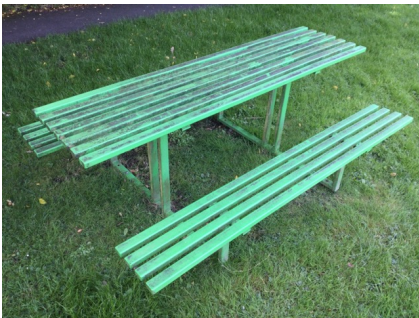
The equipment is dirty or algae covered.

Clean off.

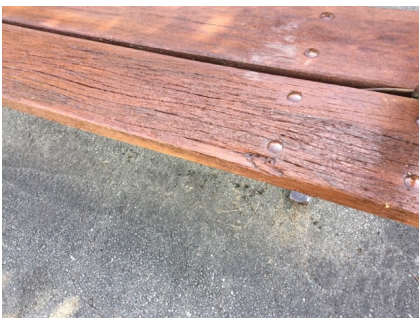
Timber is splintered.

Repair.

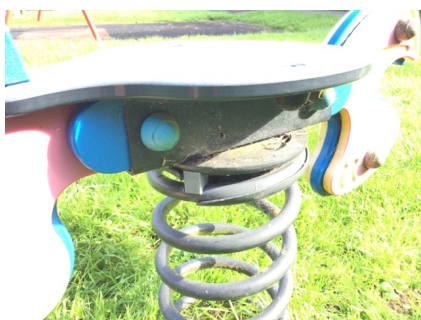
Bolt(s) loose.

Rocker body bolts to connectors.

Tighten.

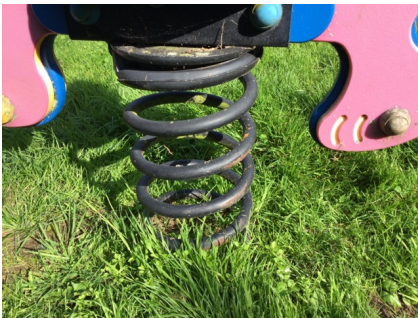
The spring is rusty. These have been known to fail without warning, leading to a collapse of the unit.

Monitor.

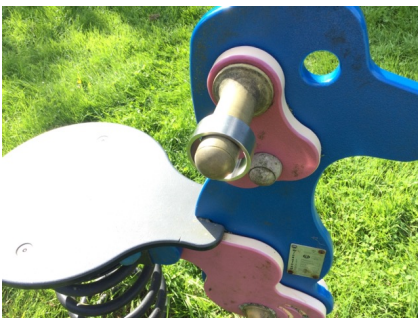
Protruding handles / foot rests.

No reasonably practicable action is identified.

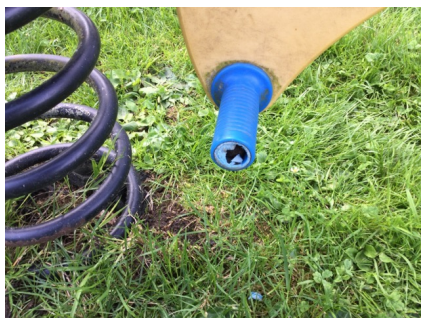
Cap missing.

Replace.

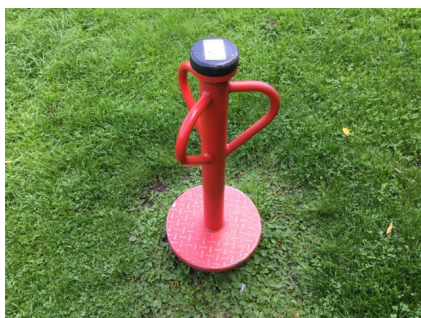
Bearings require service.

Service the bearings.

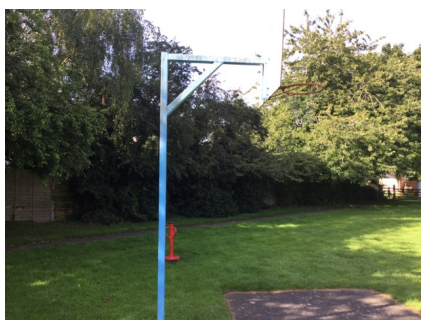
Loose in ground.

Slightly loose in the ground socket and leaning forwards.

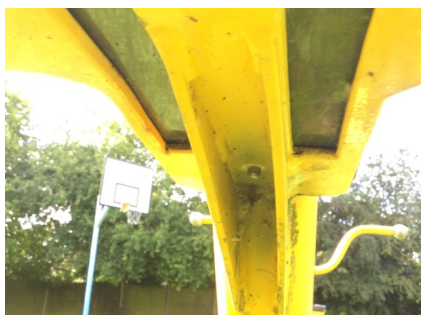
Fixtures loose or missing.

One seat bolt fixtures. Replace.
Hand hold bolts. Tighten.

Tighten/replace.

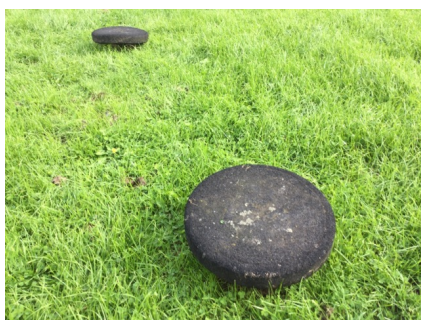
Item is not secure.

Both rubber tops.

Secure.

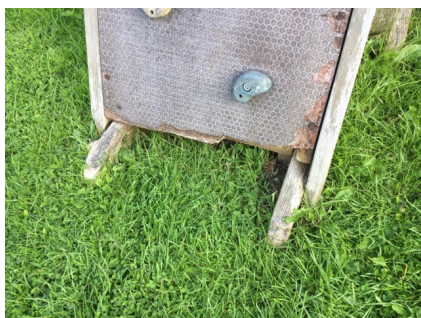
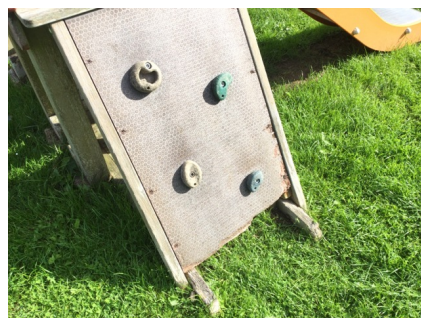
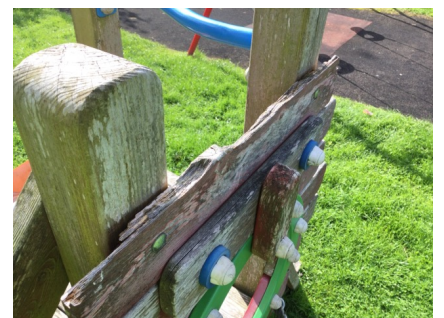
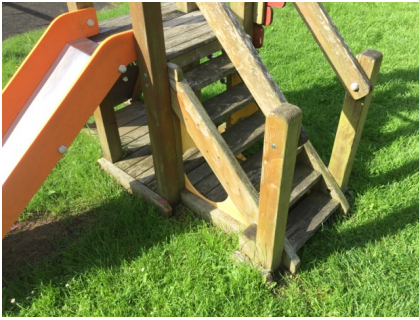
Timber is not in good condition.

Several timbers throughout unit. Replace.

Replace.

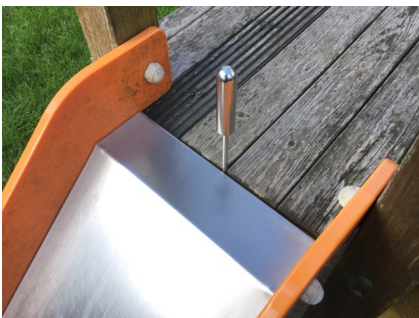
Finger entrapment.

Platform gaps.

Eliminate the entrapment.

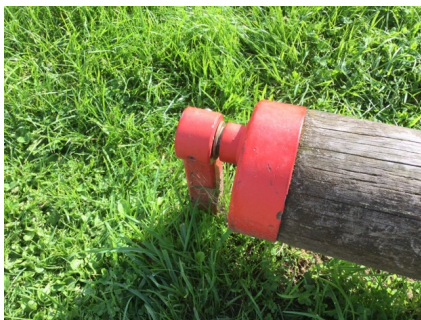
The supporting components should be dismantled and inspected according to the manufacturer's instructions. This will need doing on a regular basis, as defined by the manufacturer. This can lead to a high risk if no action is taken.

Unit has limited movement.

Dismantle and inspect according to manufacturer's instructions.

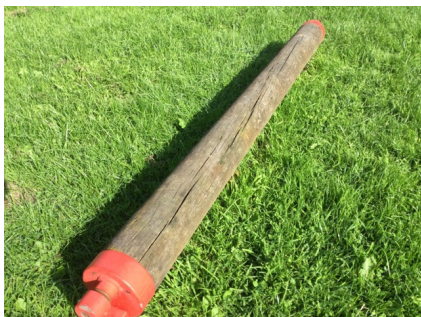
There are natural splits / shakes in the timbers.

Monitor and sand back any splintered edges as required., Shakes vary. Monitor and consult manufacturer if dimensions exceed 8 mm at sections used to grip / grasp., There are shakes running through fixing points. Ensure the fixings are fully secure on regular basis.

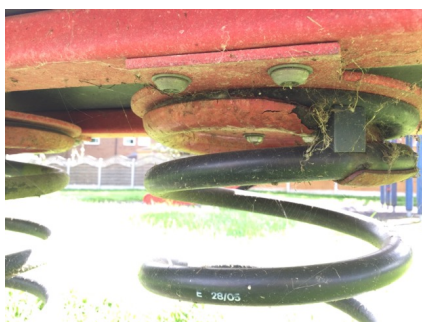
Item is rusting in places.

Spring connectors.

Descale.

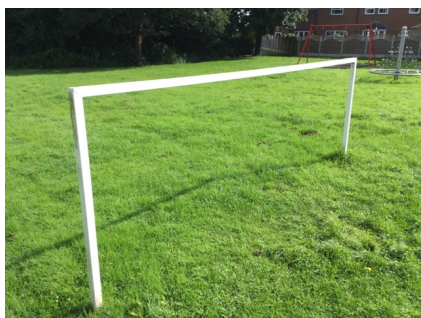
Loose in ground.

Repair.

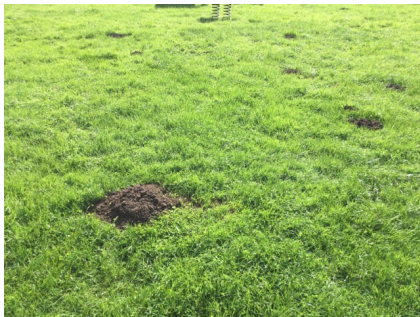
Mole hills present.

Throughout.

Eliminate.

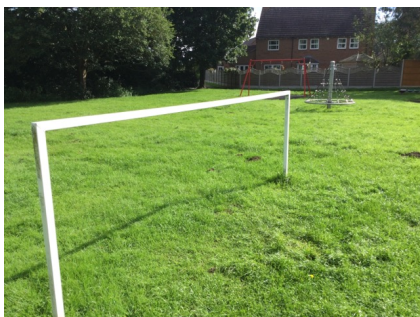
Risk assessment.

Balls may leave the area and strike a user of the play equipment.

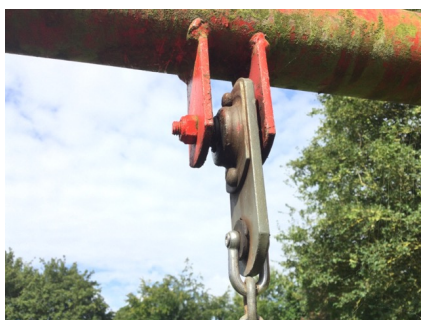
There is wear in the bushes.

One hanger bush.

Remove shackle bolt and check bush and shackle pin wear, replacing as necessary.

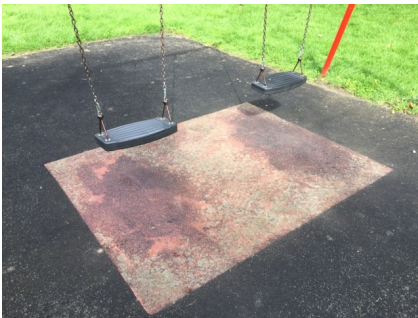
There is wear to the surfacing due to foot drag.

Although the seats are set at an acceptable height it is recommended that these are raised by 100 mm to help prevent wear.

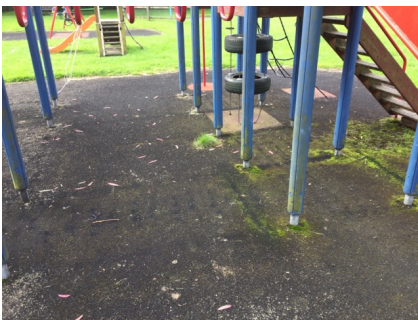
Algae growth giving slippery conditions.

Powerwashing is recommended. Care should be taken to ensure that the material can sustain high pressure washing.

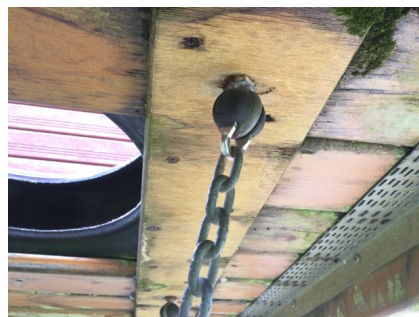
Some chain wear.

Monitor for further deterioration and replace before 40% wear.

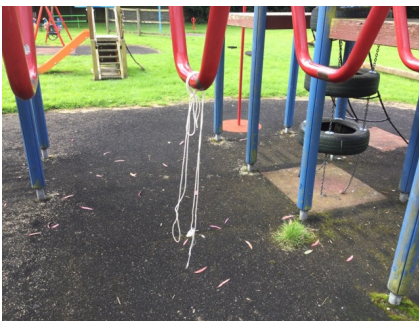
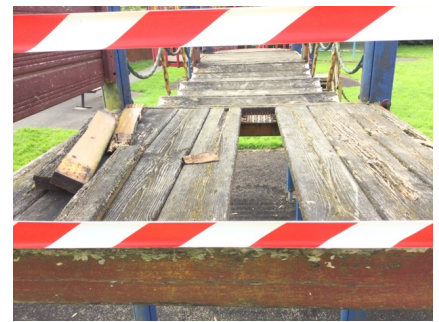
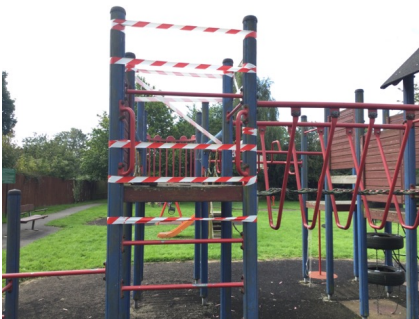
Fixtures loose or missing.

Slide tower roof is loose due to missing fixings.

Item is damaged.

Unit has been taped off from users due to damage to unit. Replace and repair damaged sections.
Remove attached ropes.

Tighten/replace.

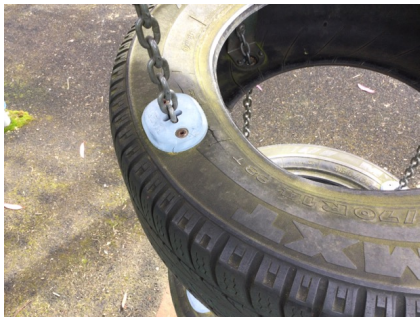
Item edges are worn.

Tyres are worn exposing metal frames. Replace.

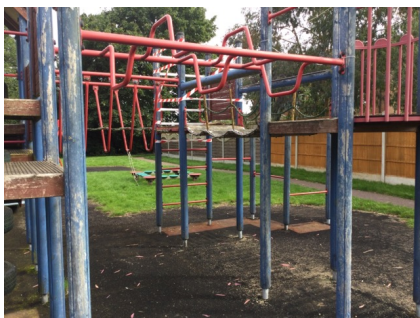
The protective surface under all bars and rings must be kept in good condition.

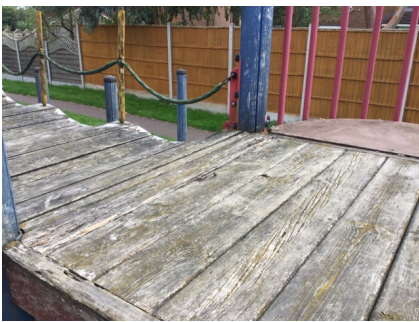
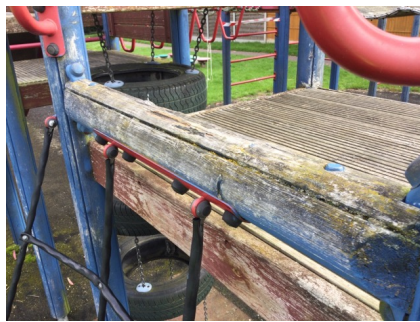
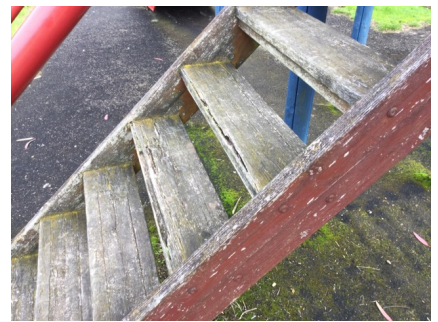
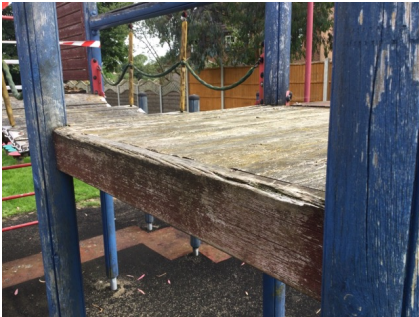
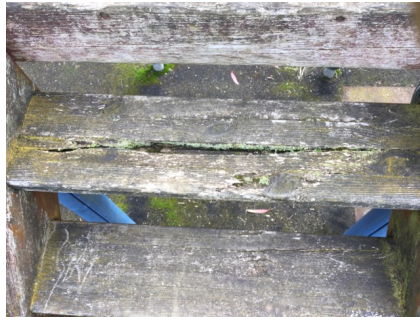
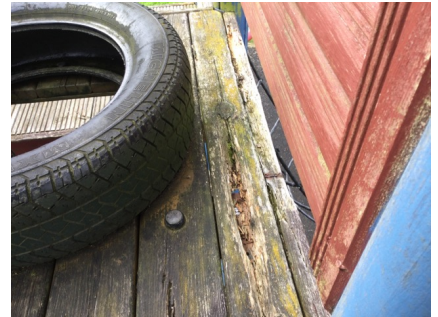
Timber is not in good condition.

Several timbers throughout unit. Replace affected parts.
Replace access steps and platform timbers.

Replace., Repair.
