Safety Inspection Report

Annual Inspection

Stoughton PC - Gaulby Lane Play Area

20 August 2024

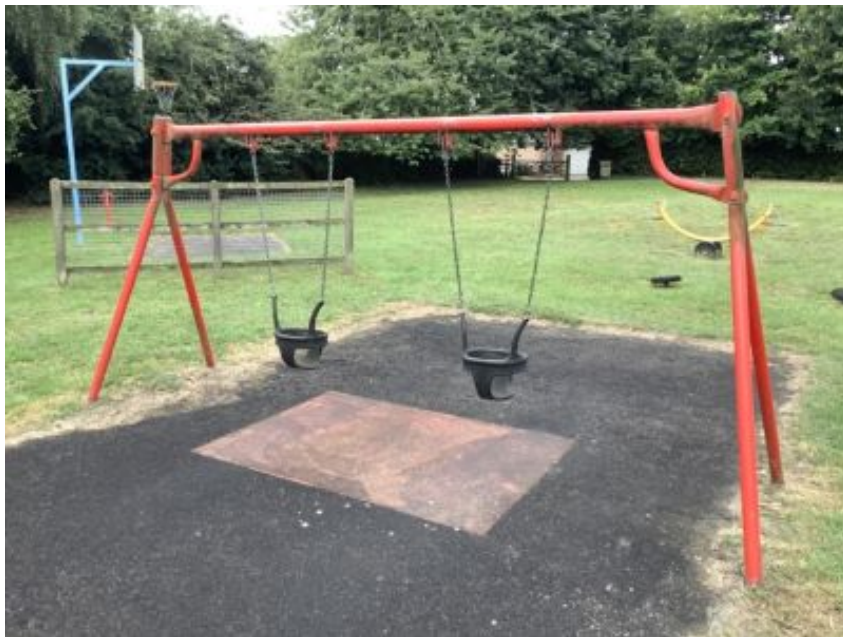
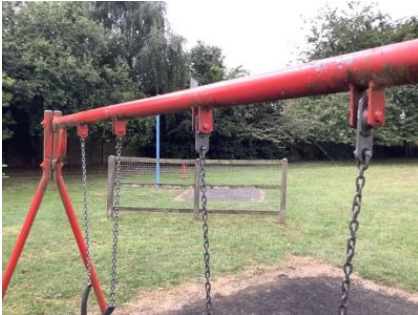
Swing - Toddler - 1 Bay 2 Seat

There is wear to the surfacing due to foot drag.

Although the seats are set at an acceptable height it is recommended that these are raised by 100 mm to help prevent wear.

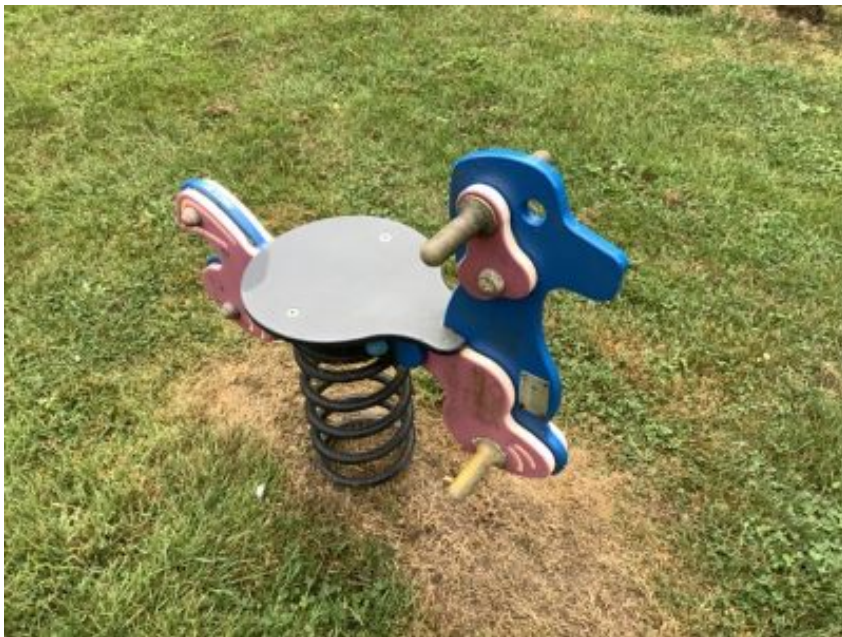
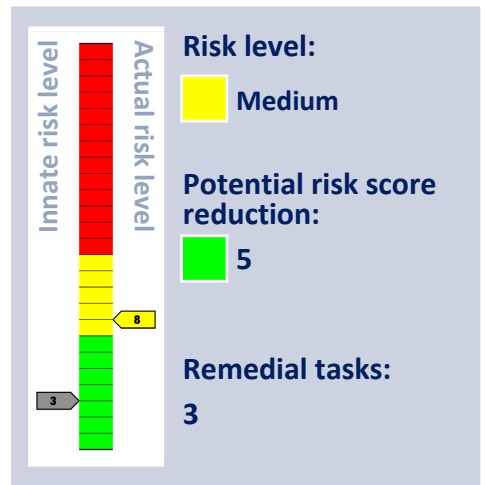
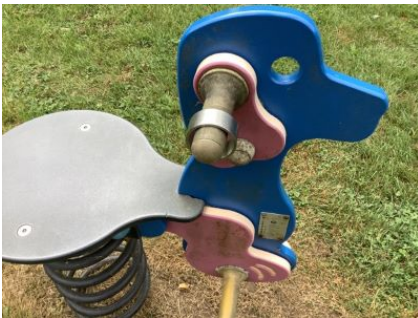
Rocker - Dog

Fixtures loose or missing.

Rocker body bolts to connectors.
Cap/s are missing allowing water ingress into the frame and fixtures. Replace.

The spring is rusty. These have been known to fail without warning, leading to a collapse of the unit.

Tighten/replace.

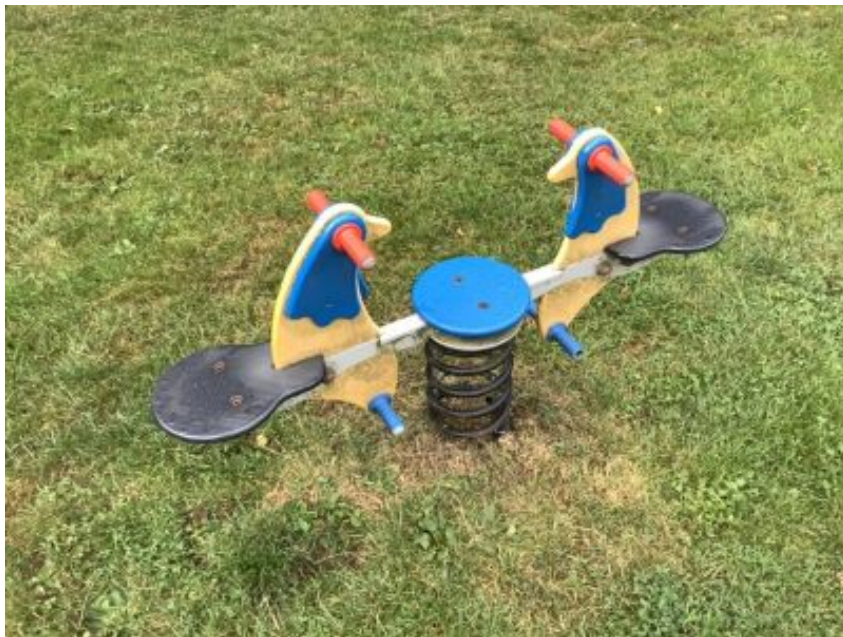
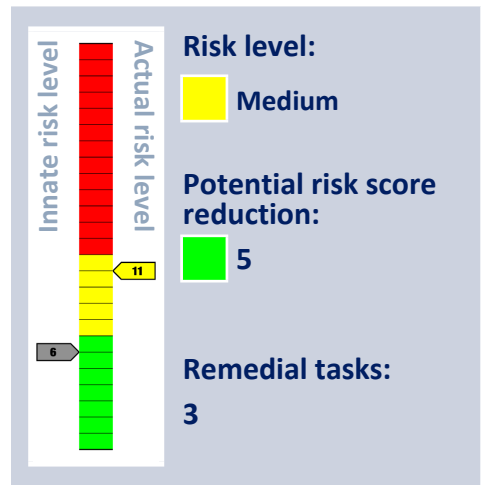
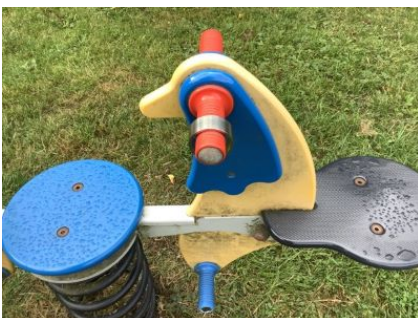
Rocker - Seesaw

Cap missing.

Fixtures loose or missing.

Foundation plate is very loose. Secure.

Replace.

Tighten/replace.

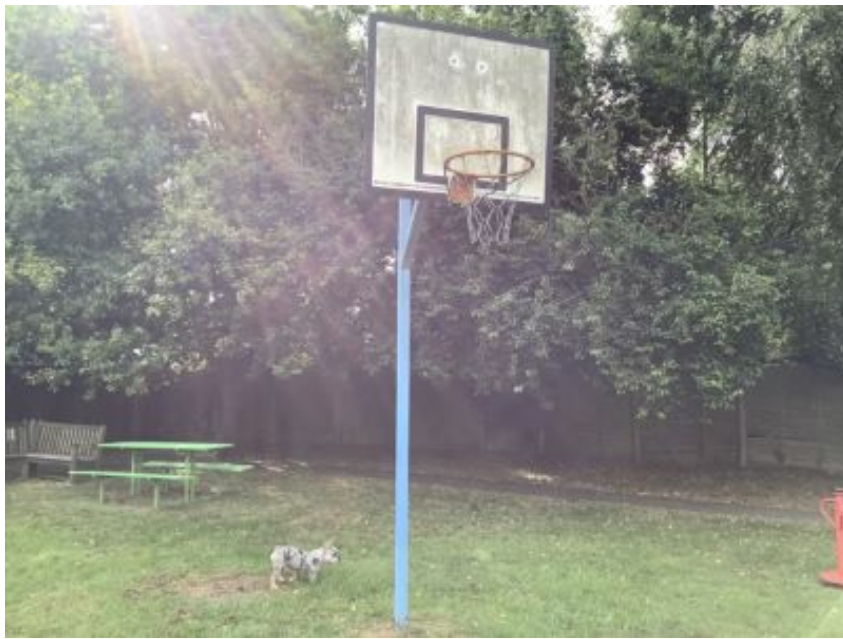
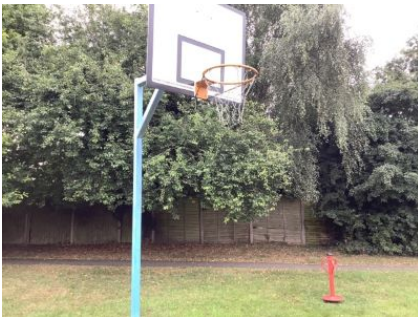
Basketball Post

Loose in ground.

Slightly loose in the ground socket and leaning forwards.

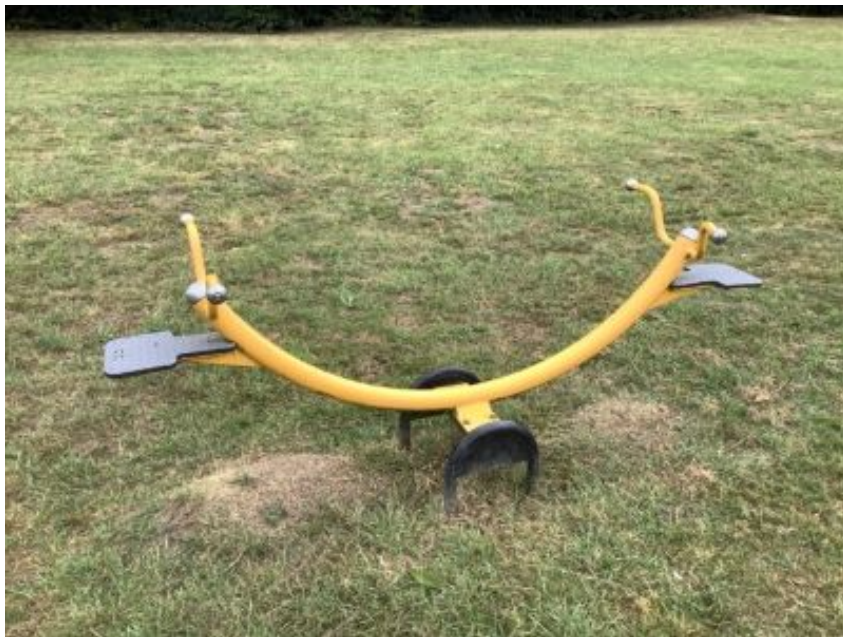
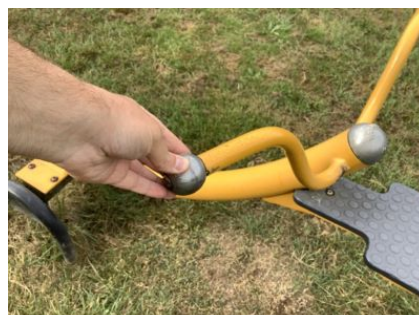
Rocker - Seesaw - Gullwing

Fixtures loose or missing.

One seat bolt fixtures. Replace.
Hand hold bolts. Tighten.

Tighten/replace.

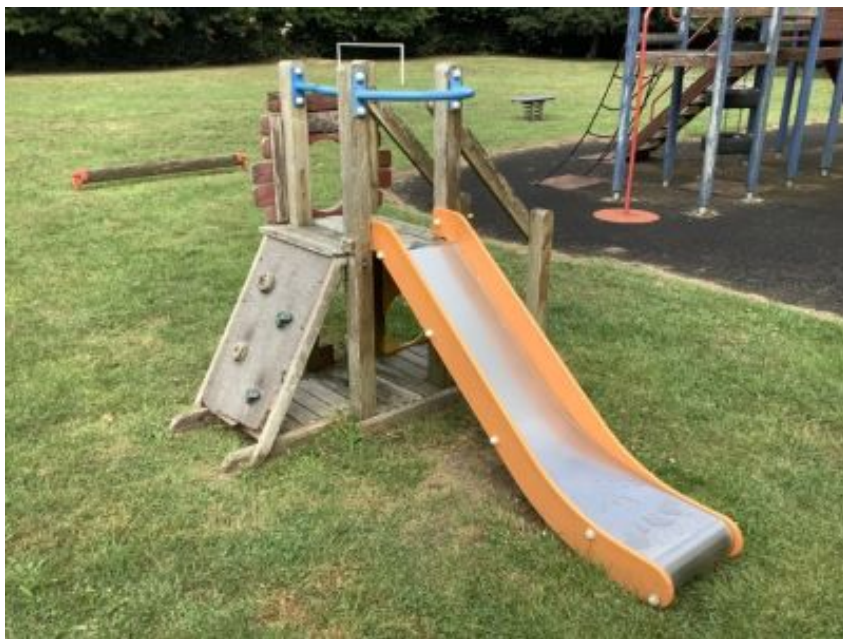
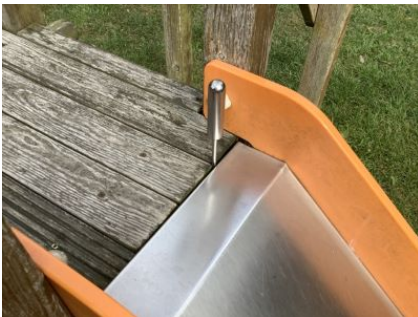
Multiplay - Toddler

Timber is not in good condition.

Several timbers throughout unit. Replace.

Replace.

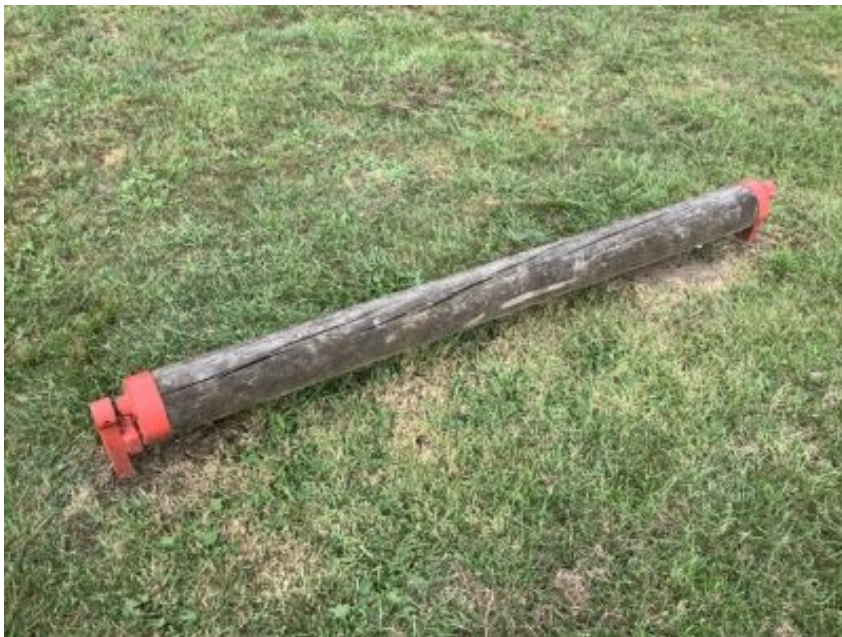
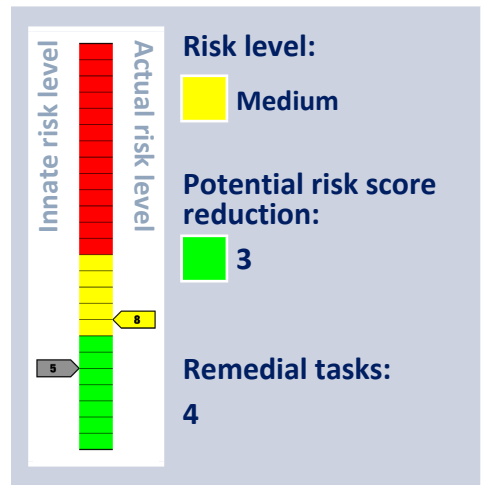
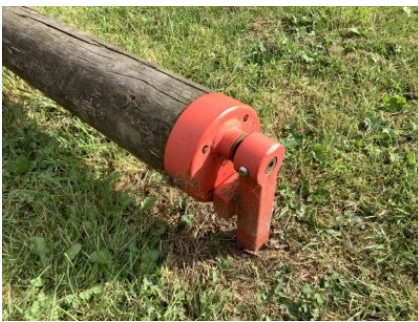
Agility - Roller Balance Beam

Monitor shakes for decay.
Monitor all natural timber shakes. Shakes are creating slight splintering. Smooth off if necessary.

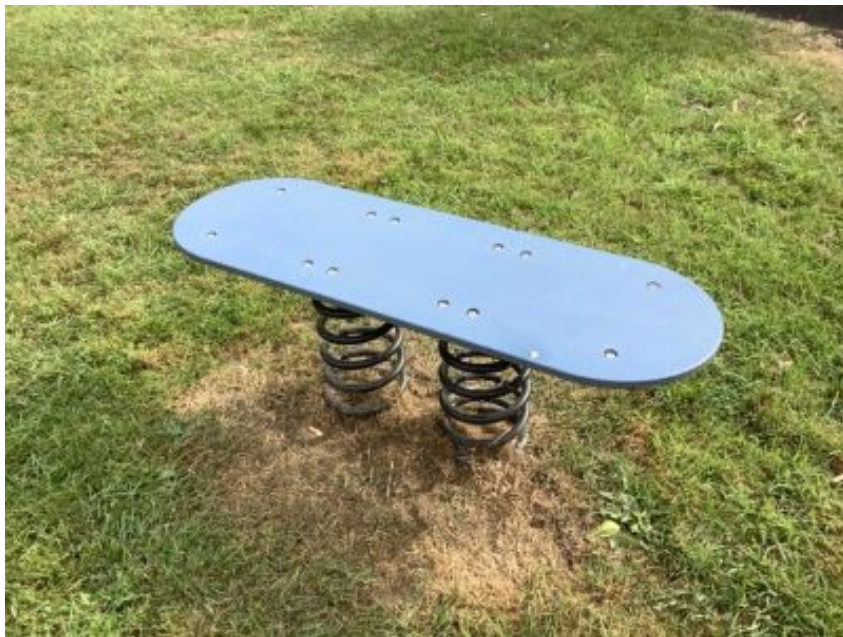
Agility - Wobble Board

Item is rusting in places.

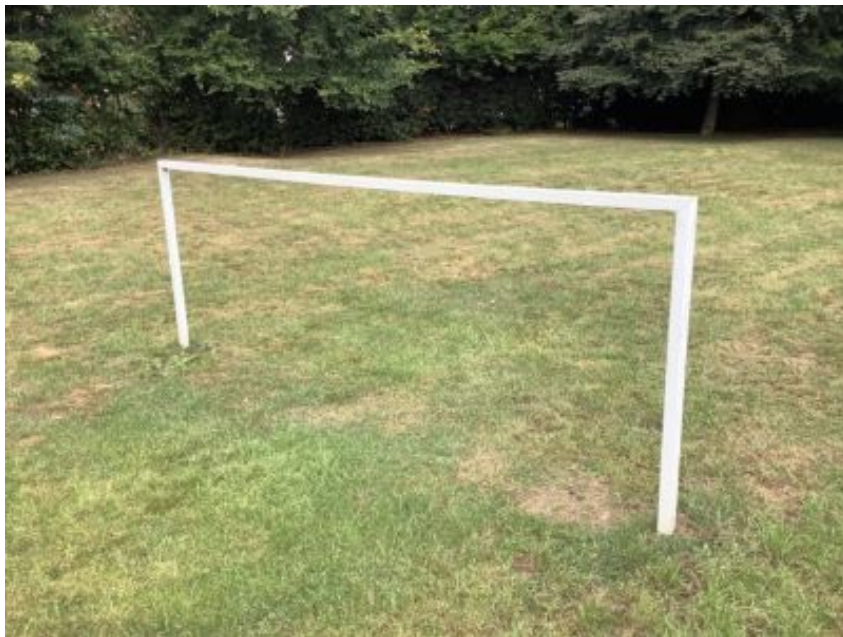
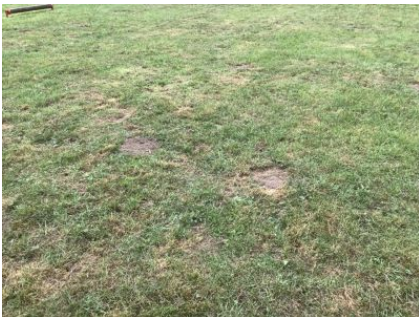
Football Goal

Loose in ground.

Repair.

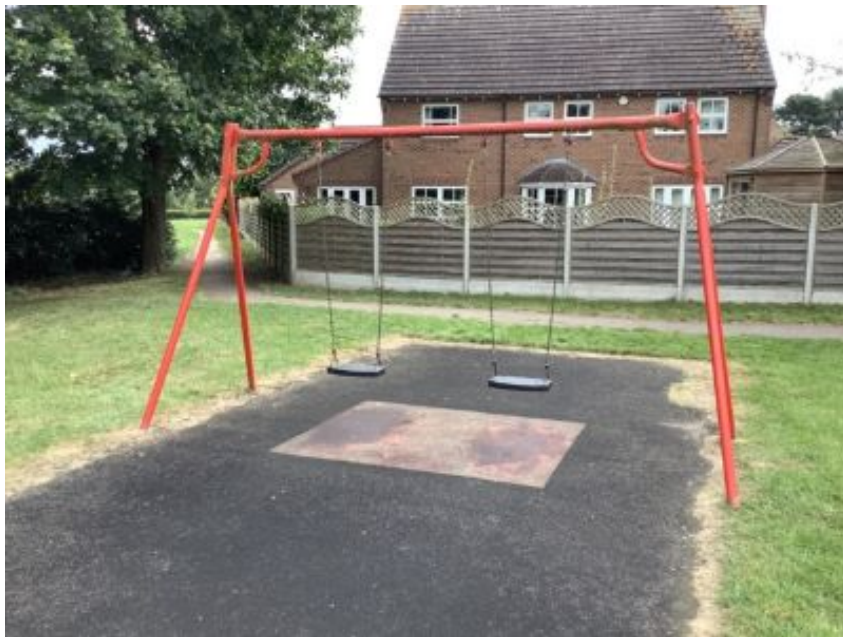
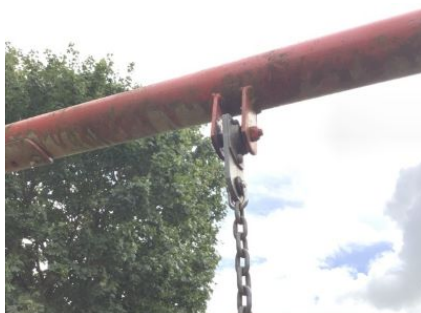
Swing - Junior - 1 Bay 2 Seat

There is wear in the bushes.

Some chain wear.

There is wear to the surfacing due to foot drag.

Remove shackle bolt and check bush and shackle pin wear, replacing as necessary.

Monitor for further deterioration and replace before 40% wear.

Although the seats are set at an acceptable height it is recommended that these are raised by 100 mm to help prevent wear.

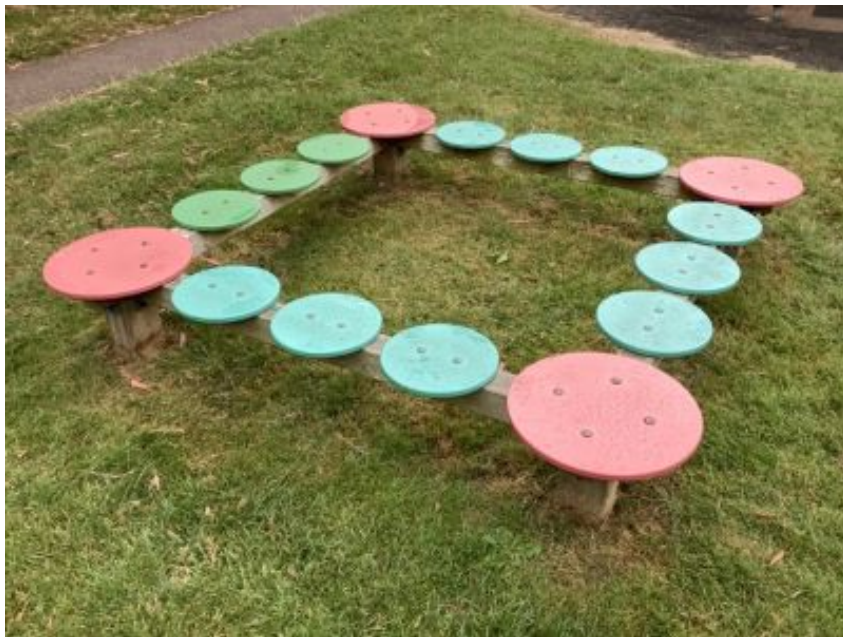
Agility - Balance Trail

Bolt(s) loose.

Multiple loose panels.

Strimmer damage is present on posts, allowing water to enter and timbers to soften. It can also remove the protective envelope around the timber. Prevent further damage and check timbers for decay throughout the year.

Strimmer damage is present on posts, allowing water to enter and timbers to soften. Prevent further damage and check timbers for decay throughout the year.

Prevent further damage.

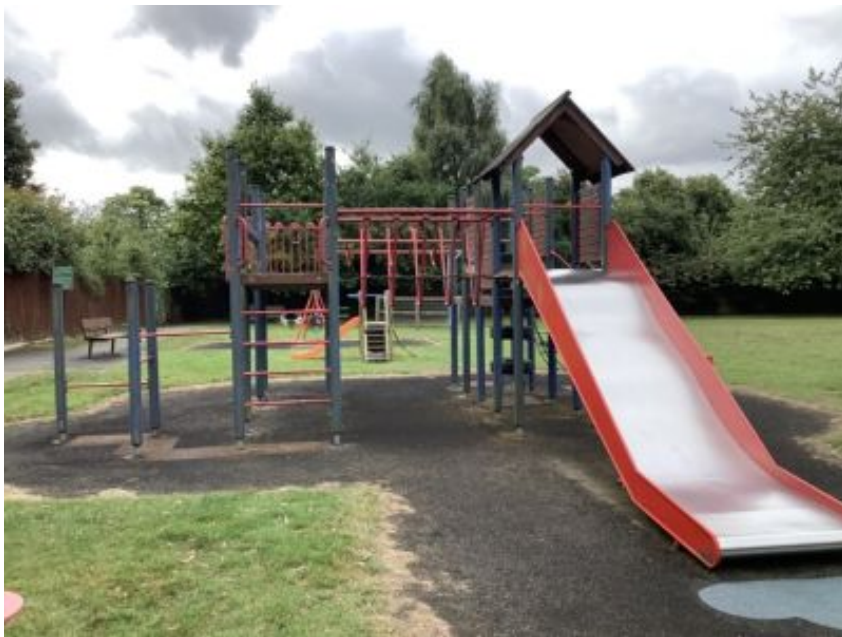
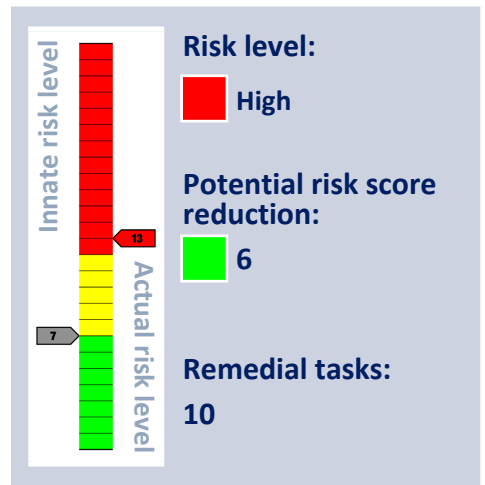
Multiplay - Senior is in poor condition. Unit is in need of several repairs and replacements.

Algae growth giving slippery conditions.

Some chain wear.

All chain covers are damaged leaving sharp edges. Replace.

Slide tower roof is loose due to missing fixings.

Item is damaged.

Item edges are worn.

Tyres are worn exposing metal frames. Replace.

Timber is not in good condition.

Powerwashing is recommended. Care should be taken to ensure that the material can sustain high pressure washing.

Monitor for further deterioration and replace before 40% wear.

Remove chain covers to inspect according to manufacturer's instructions, and replace the covers when done.

Tighten/replace.

Replace and repair damaged sections.

The protective surface under all bars and rings must be kept in good condition.

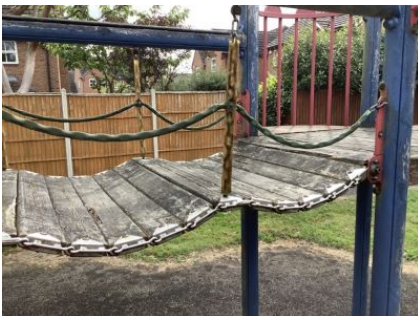
Several timbers throughout unit. Replace affected parts.
Replace access steps and platform timbers.

Replace., Repair.
