Safety Inspection Report

Annual Inspection

Stoughton PC - Gaulby Lane Play Area

07 August 2023

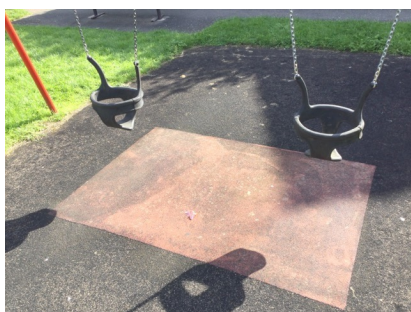
Swing - Toddler - 1 Bay 2 Seat

There is wear to the surfacing due to foot drag.

Although the seats are set at an acceptable height it is recommended that these are raised by 100 mm to help prevent wear.

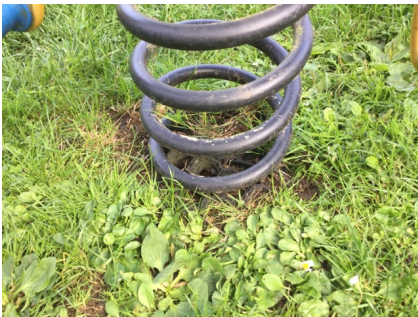
Rocker - Seesaw

Fixtures loose or missing.

Foundation plate is very loose. Secure.

Tighten/replace.

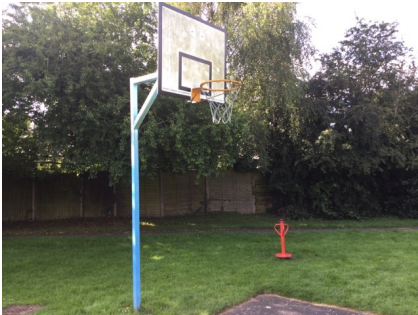
Basketball Post

Loose in ground.

Slightly loose in the ground socket and leaning forwards.

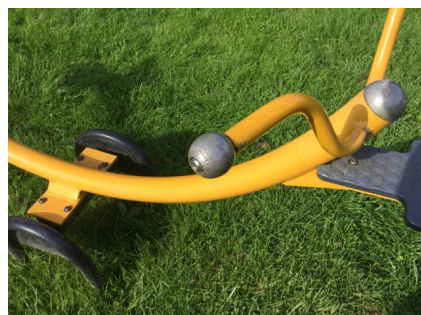
Rocker - Seesaw - Gullwing

Fixtures loose or missing.

One seat bolt fixtures. Replace.
Hand hold bolts. Tighten.

Tighten/replace.

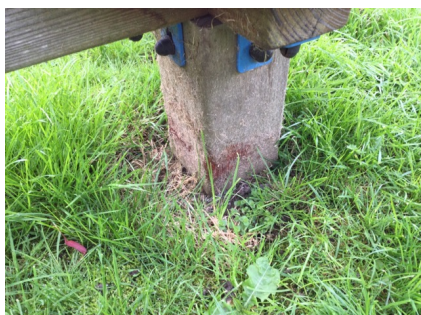
Agility - Balance Trail

Strimmer damage to supports is likely to accelerate timber rot.

Strimmer damage is present on posts, allowing water to enter and timbers to soften. Prevent further damage and check timbers for decay throughout the year.

Prevent further damage.

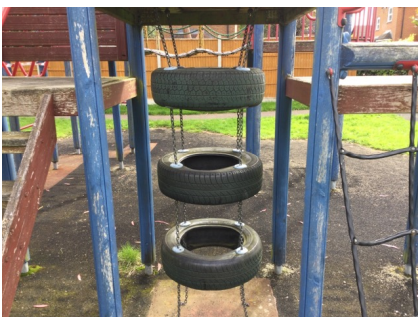
Multiplay - Senior

Some chain wear.

Monitor for further deterioration and replace before 40% wear.

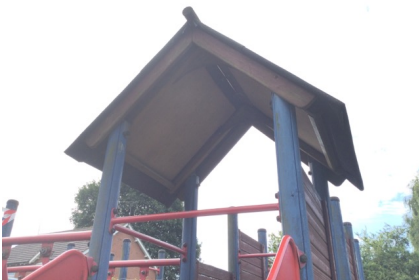
Fixtures loose or missing.

Slide tower roof is loose due to missing fixings.

Tighten/replace.

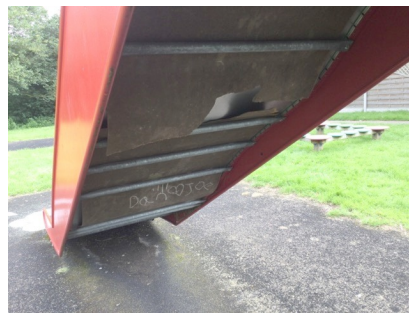
Item is damaged.

Unit has been taped off from users due to damage to unit. Replace and repair damaged sections.
Remove attached ropes.

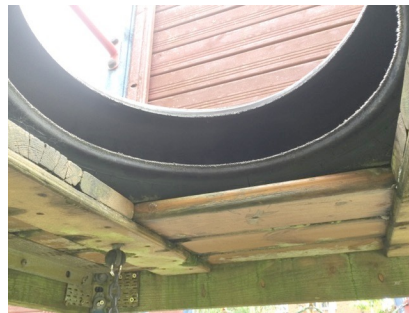
Item edges are worn.

Tyres are worn exposing metal frames. Replace.

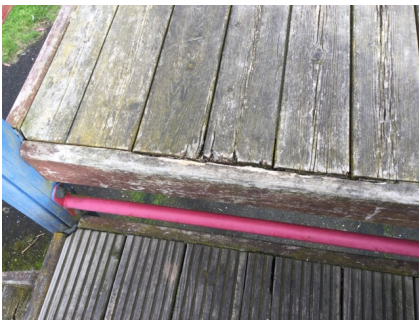
Timber is not in good condition.

Several timbers throughout unit. Replace affected parts.
Replace access steps and platform timbers.

Replace., Repair.
